Monitoring Completed Navigation Projects (MCNP) Program

Montgomery Point Lock and Dam, White River, Arkansas

Allen Hammack, Michael Winkler, and Howard Park

January 2016

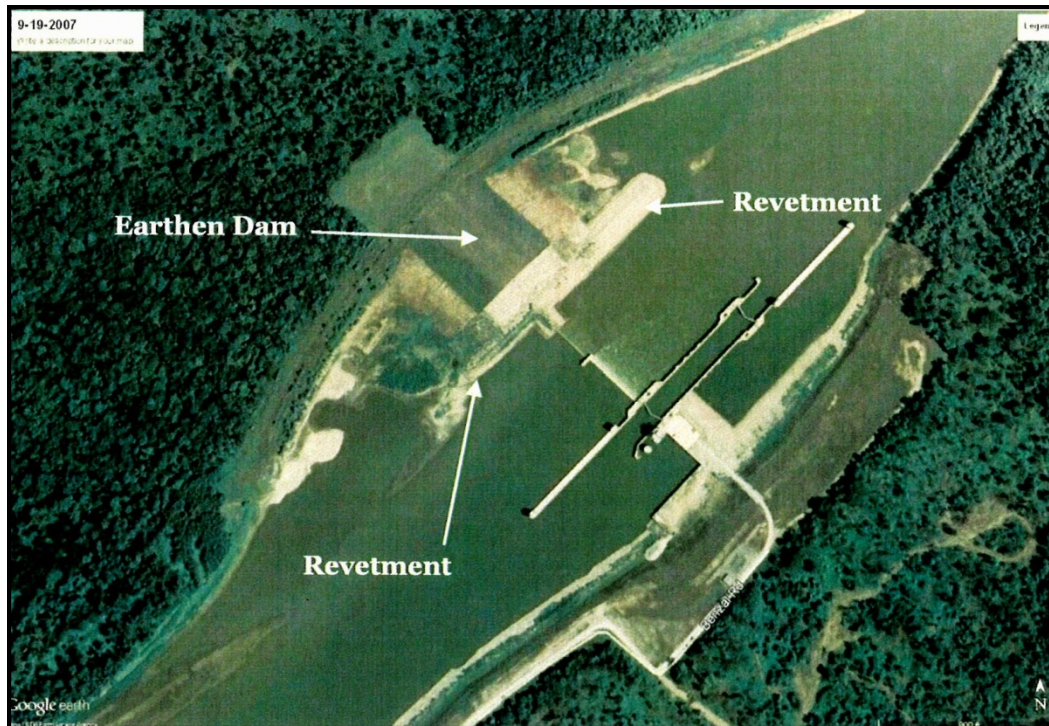
Figure 9. MPLD at low water, 19 September 2007, 3 years after construction. Note sediment accumulation upstream and downstream of earthen dam behind revetments (photo from Google Earth).

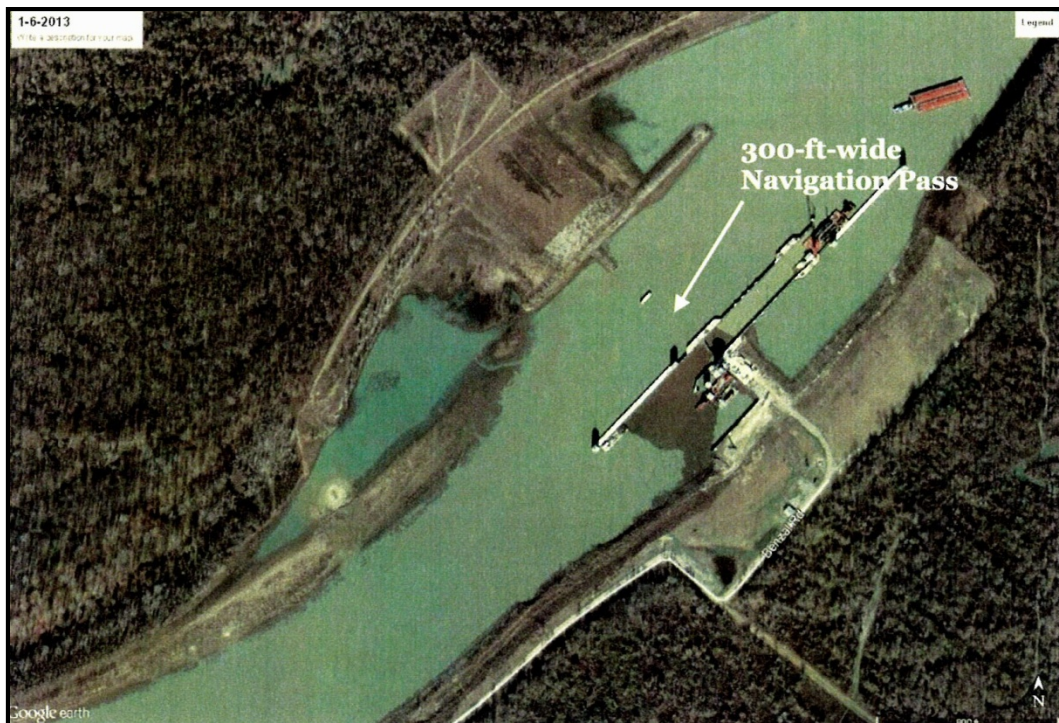
Figure 11. MPLD, 6 January 2013. Note continuing sediment accumulation upstream of earthen dam, infringing on navigation channel (photo from Google Earth).

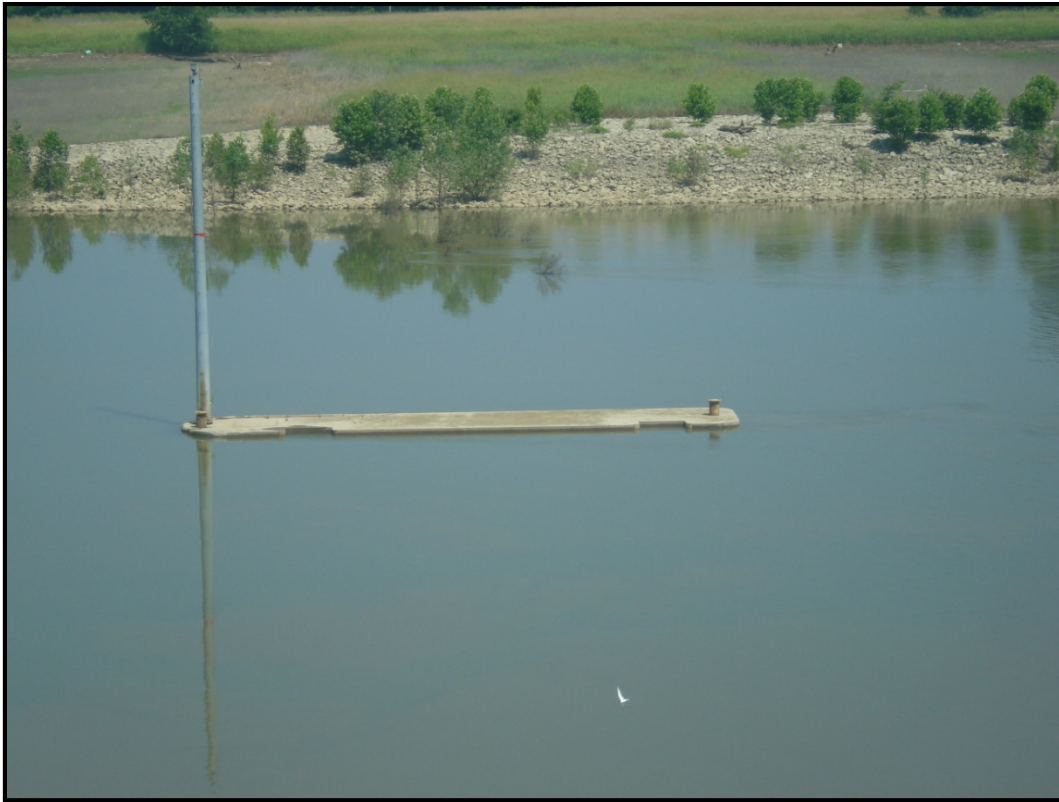
Figure 21. Navigation pass concrete abutment pier may become a hazard at high water.

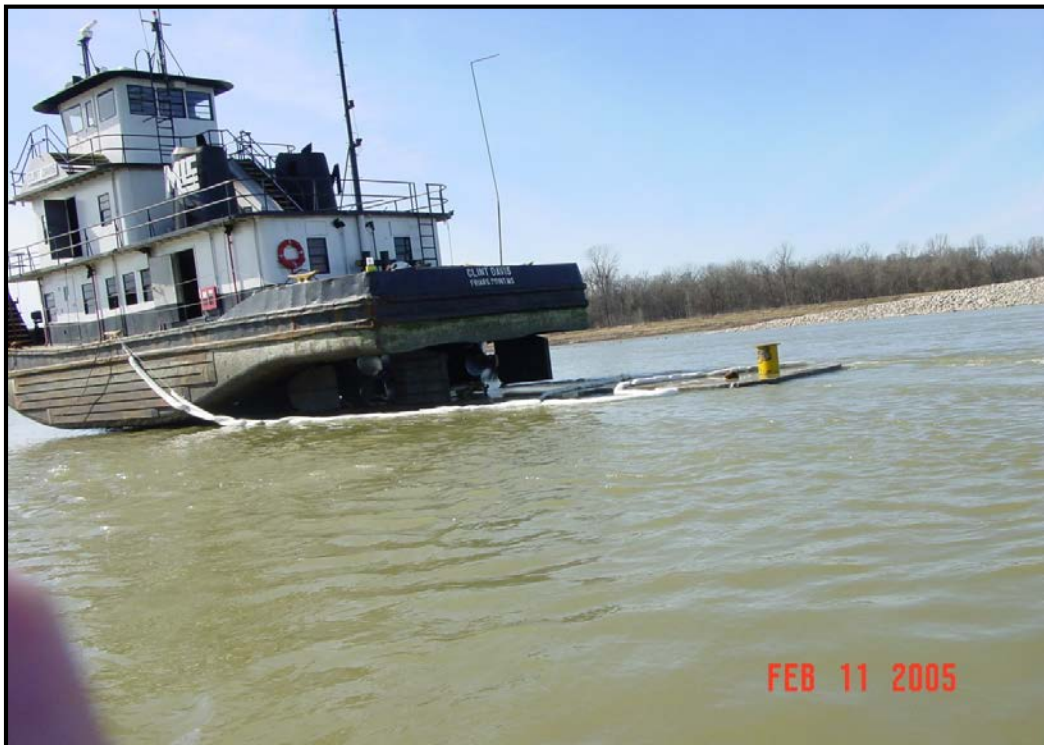
Figure 22. Tow boat allision with navigable pass concrete abutment pier at high water.

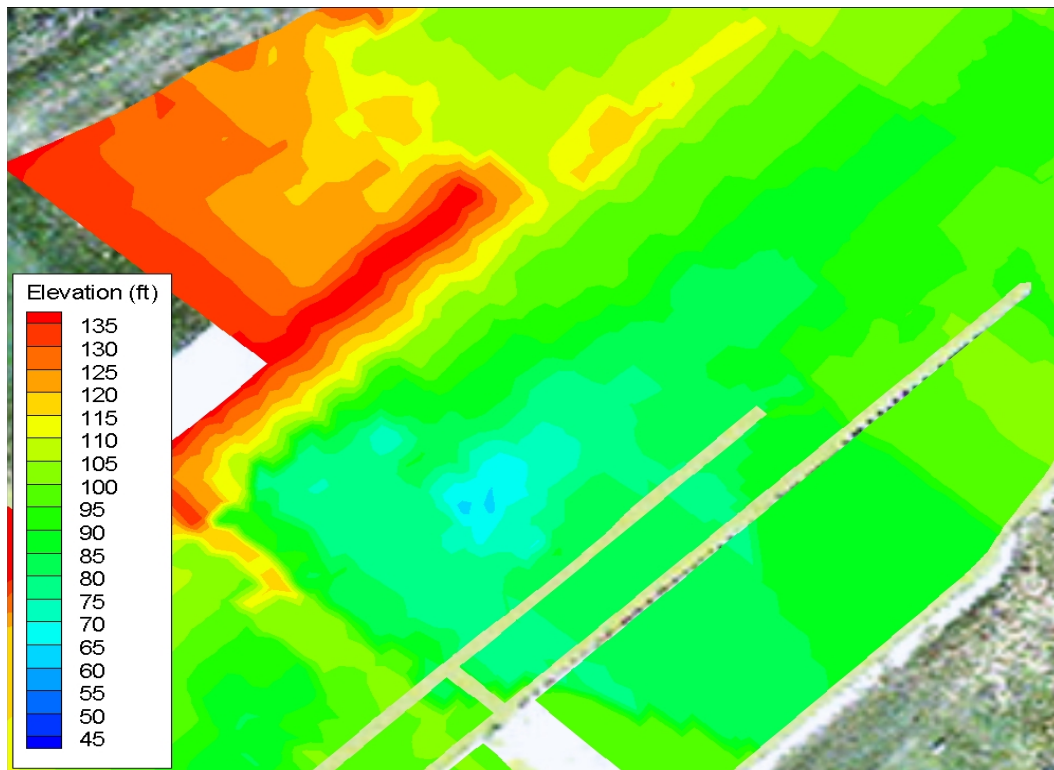
Figure 26. Closeup view of scour hole bathymetry downstream of MPLD navigation pass, May 2008. Scour hole bottom elevation approximately 68 ft NGVD29.

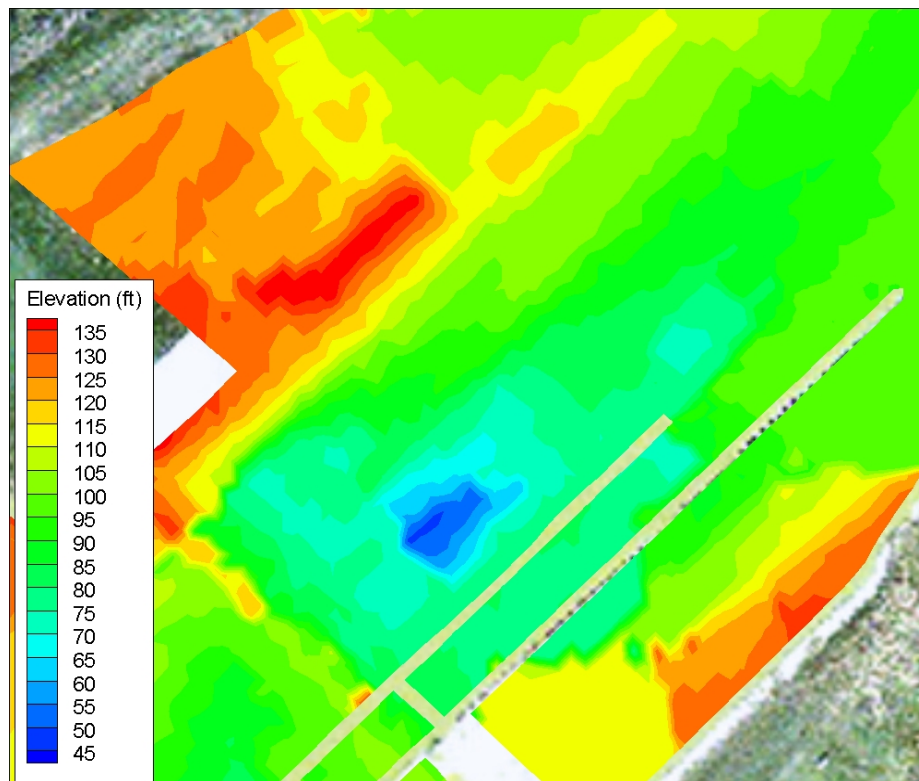
Figure 25 (June 2009 survey) shows additional deepening and widening in the area just downstream of the stone protection of the navigable pass stone and north of the lock stone protection to approximately elevation 45 ft NGVD29.

Figure 27. Closeup view of scour hole bathymetry downstream of MPLD navigation pass, June 2009. Scour hole bottom elevation approximately 45 ft NGVD29.

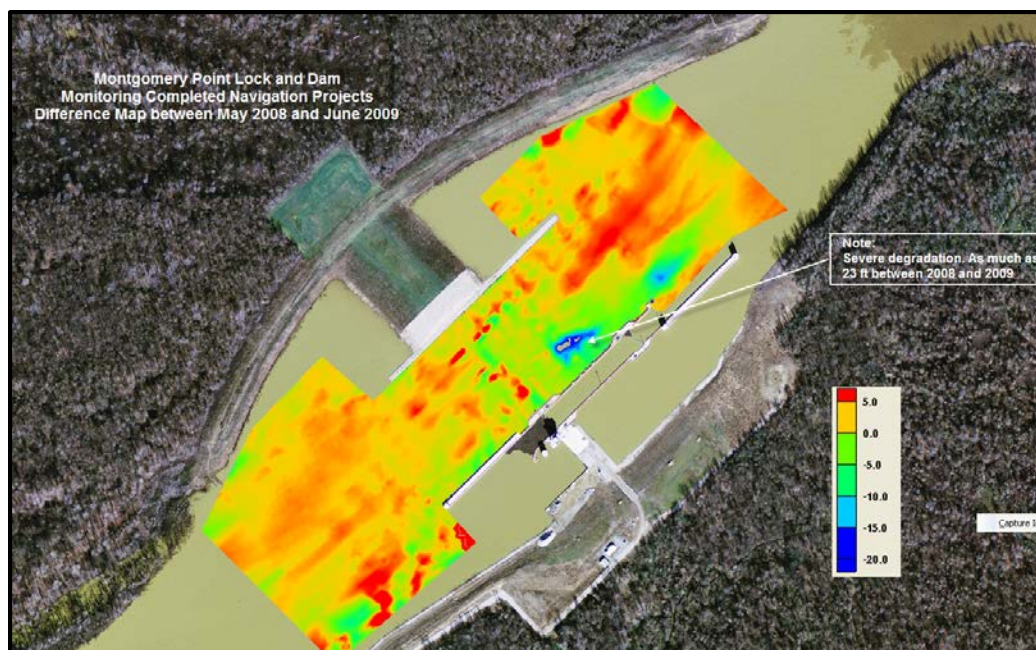
Figure 28. Difference map showing change in channel elevation between May 2008 and June 2009, vicinity of MPLD. Up to 23 ft of additional degradation occurred in scour hole below navigation pass during this time period.

Himstedt (2015, personal communication) stated that dredged material had been placed in the scour hole in 2007 and covered with four work-barge loads of stone, although the stone size was not available. The difference map between the May 2008 and June 2009 surveys (Figure 28) showed significant degradation and widening of the area just downstream of the stone protection of the navigable-pass stone and north of the lock stone protection. This comparison showed approximately 23 ft of additional degradation in this area, with more degradation farther downstream along the lock. The scour hole appeared to have widened and lengthened quite significantly during this time period. The scour hole was approximately 115 ft wide and 260 ft long, according to the survey of June 2009.

The scour hole developed at this specific location because river flow at high water over the fixed-bed navigation pass is analogous to high-velocity turbulent flow over a weir. The resulting high-velocity currents provide forces capable of scouring the movable bed material comprising the river bottom in this vicinity. Based on these survey data showing significant scour hole enlargement between May 2008 and June 2009, it was recommended that SWL fill and stabilize the scour hole with stone sufficiently large enough to prevent scour hole enlargement with resulting potential endangerment of the navigation structures.

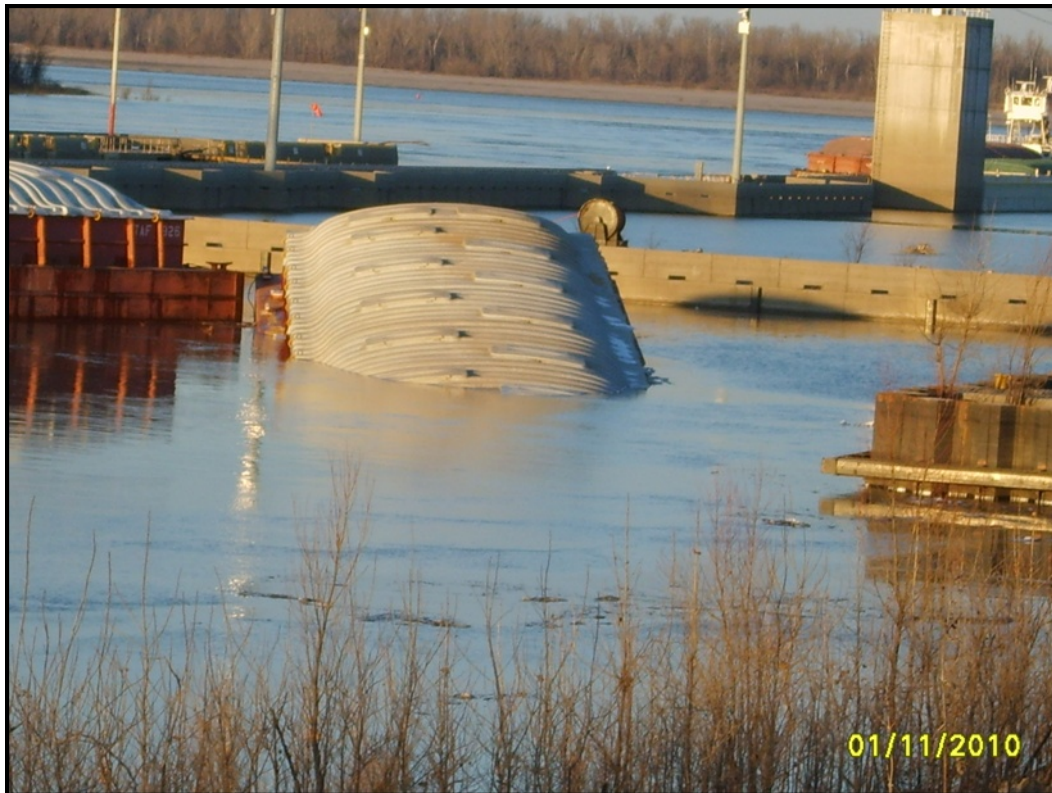
There have been five significant allisions since the lock was opened, such as the barge striking the navigation lock wall in January 2010 (Figures 40 and 41). Figure 42 shows the upstream lock guide wall that is also subject to allisions. Time-lapse video equipment was installed at the project to observe tows transiting via the navigable pass or the lock under outdraft conditions and redirected currents toward the navigable pass.

Figure 40. Barge damage after allision with MPLD navigation structure, January 2010.

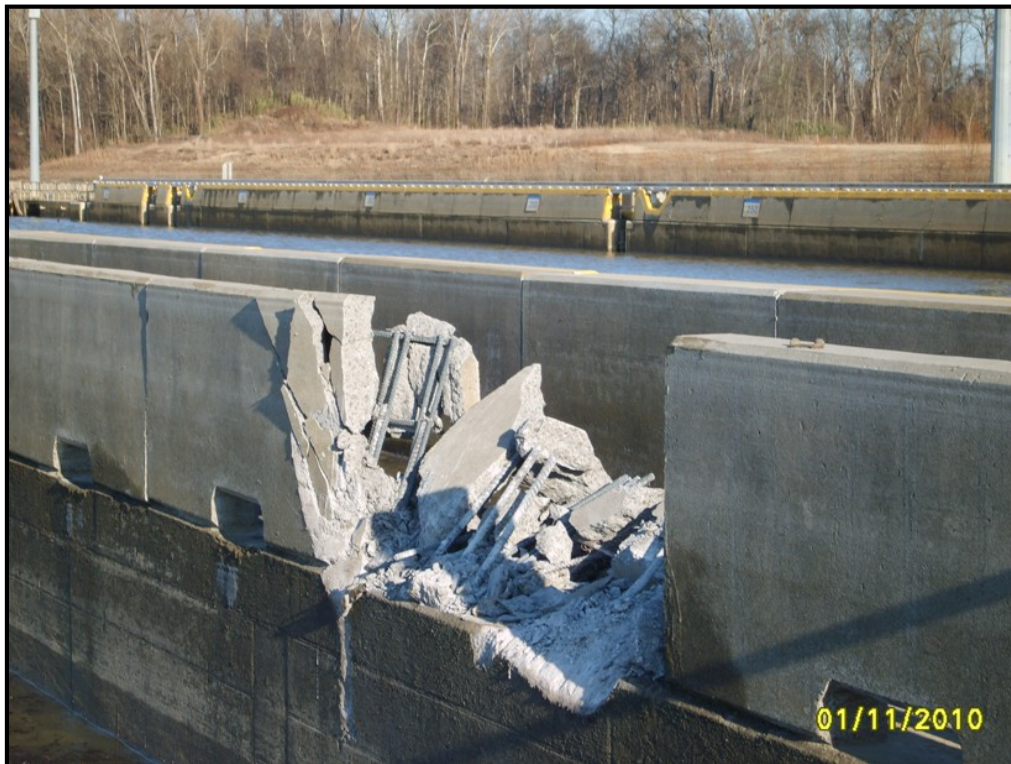
Figure 41. MPLD navigation lock parapet wall damage after being struck by barge, January 2010.

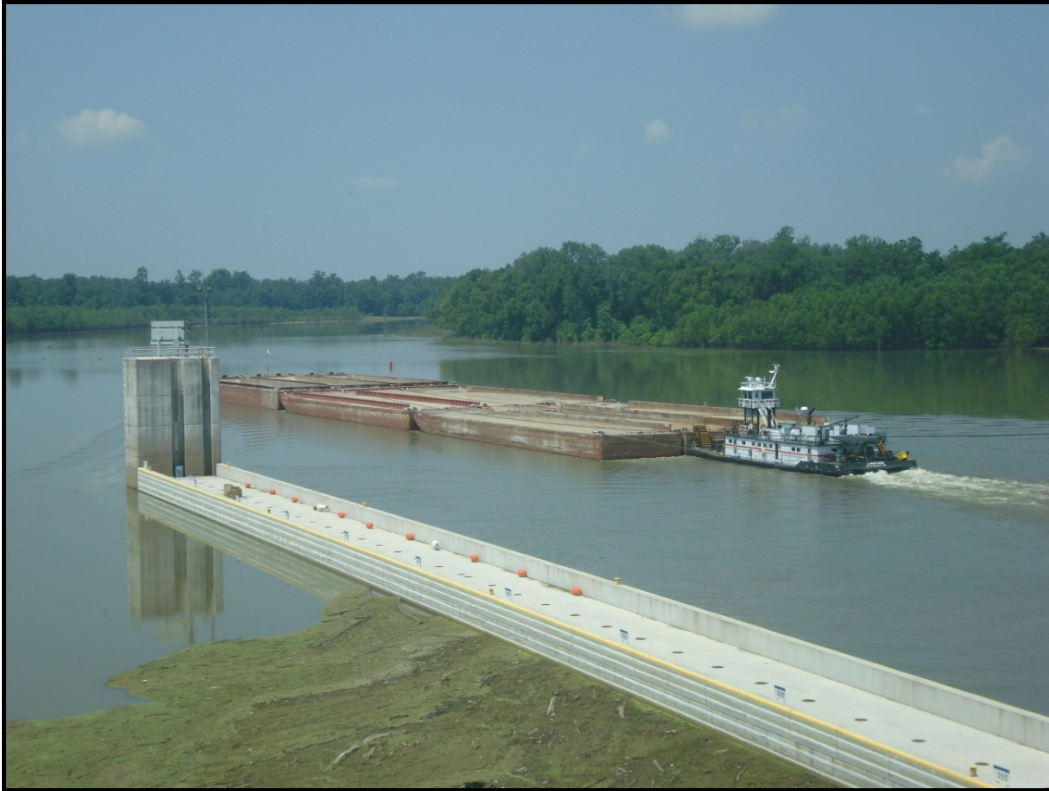
Figure 42. MPLD upstream navigation pass floating guide wall subject to allisions.
